FLOOD AND TSUNAMI FLOW IN RELATION TO THE LANDFORMS OF COASTAL AND ALLUVIAL LOWLANDS-CASE STUDY IN HAT YAI AND BANDA ACEH PLAINS

Masatomo UMITSU

Nagoya University

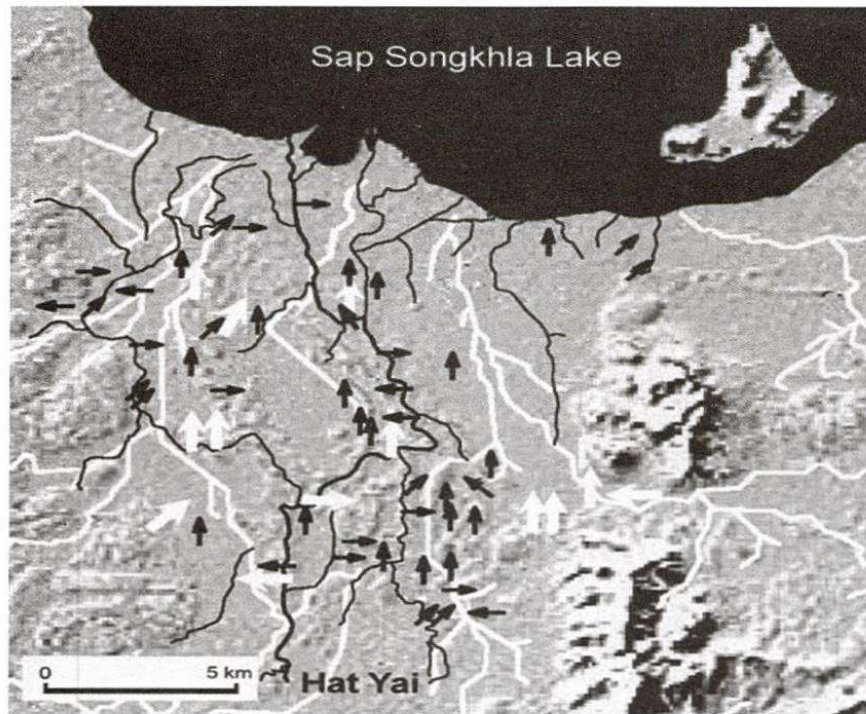
Fig. 3 Flood water direction and DDM (Draiage Direction Matrix). Black line: rivers, White line: Draiage Direction Matrix, Large white arrow: fast flood flow, small black arrow: slow flood flow

General direction of the flood flow was mostly from south to north, and there were also several flows from both sides of the plain. Relatively strong northward flood flows were observed in the northeastern part of the city and in the western part of the Hat Yai Plain. There was also a strong northwestward flood flow in the northwestern part of the city. This was due to the existence of the abandoned railway embankment. The flood flow was interrupted by the embankment and it was accumulated along the embankment to the northeastern direction.

natural levee at Ta Chan from south to north. These flows were clearly shown by the virtual drainage network drawn based on SRTM-dem data. On the other hand, a strong flood flow inundated from the main river in the southern part of the Hat Yai urban area, and the stream rushed to the northeastward along the abandoned railway embankment. The flows were also shown in the virtual drainage network. The actual flood flow data collected in the field has good concordance with the virtual flood flow conducted from the SRTM virtual drainage network.

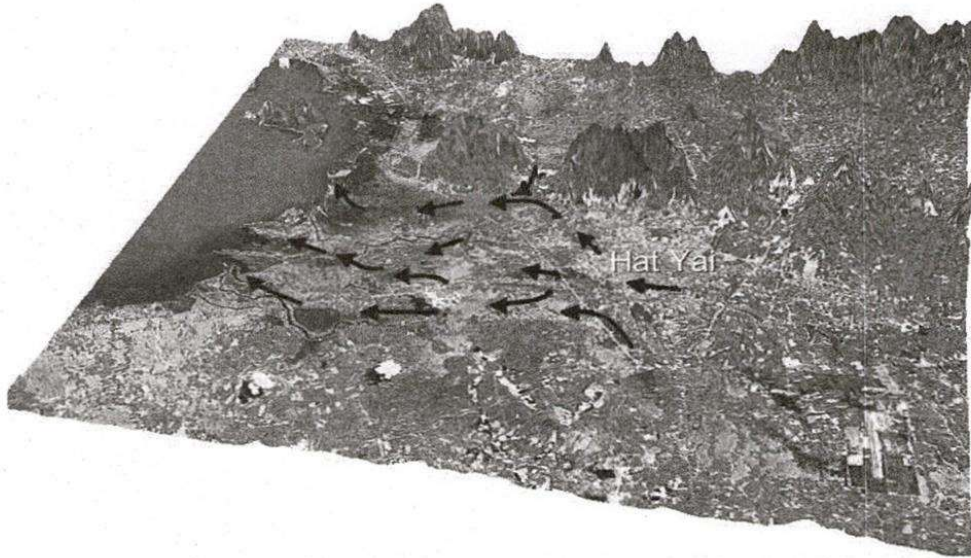
Fig. 4 Prediction of flood flow based on the research in the 3D diagram of the ASTER satellite image.

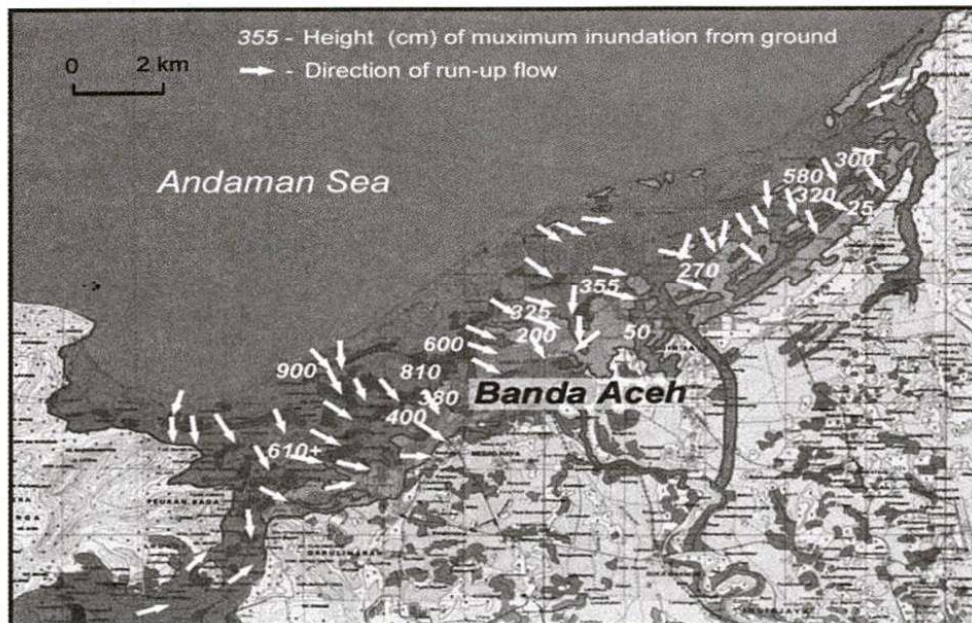
Fig. 7 Direction and height of tsunami flow in the Banda Aceh coastal plain (Umitsu et al, 2007)

Flow indicators on the Banda Aceh coastal plain generally show inundation from the northwest. However, some areas show different directions of the flow (Fig. 11). On the northeastern coast, flows spread out in a radial pattern from a gap in the sand dune along the coast. In the southwestern part of the plain, northeastward tsunami flow from the west coast penetrated the plain and the flow met in a gap of hills with the southward run-up tsunami flow of the Banda Aceh coastal plain. We also mapped indicators in the western part of the coastal plain that show southward flows deflected due to the existence of hills.

Inundation heights at similar distances from the coast were variable, with greater heights in the central and western part of the plain. The tsunami reached a height about 9 m on the ground near the port of the Banda Aceh and about 6-8 m in the western part of the plain about 2 km inland. In the eastern part of the plain about 2 km from the coast, however, tsunami heights were mostly lower than 3 m.
